» Grid Incident in South-East Europe on 21 June 2024

ICS Investigation Expert Panel » Interim (factual) Report » 4 November 2024

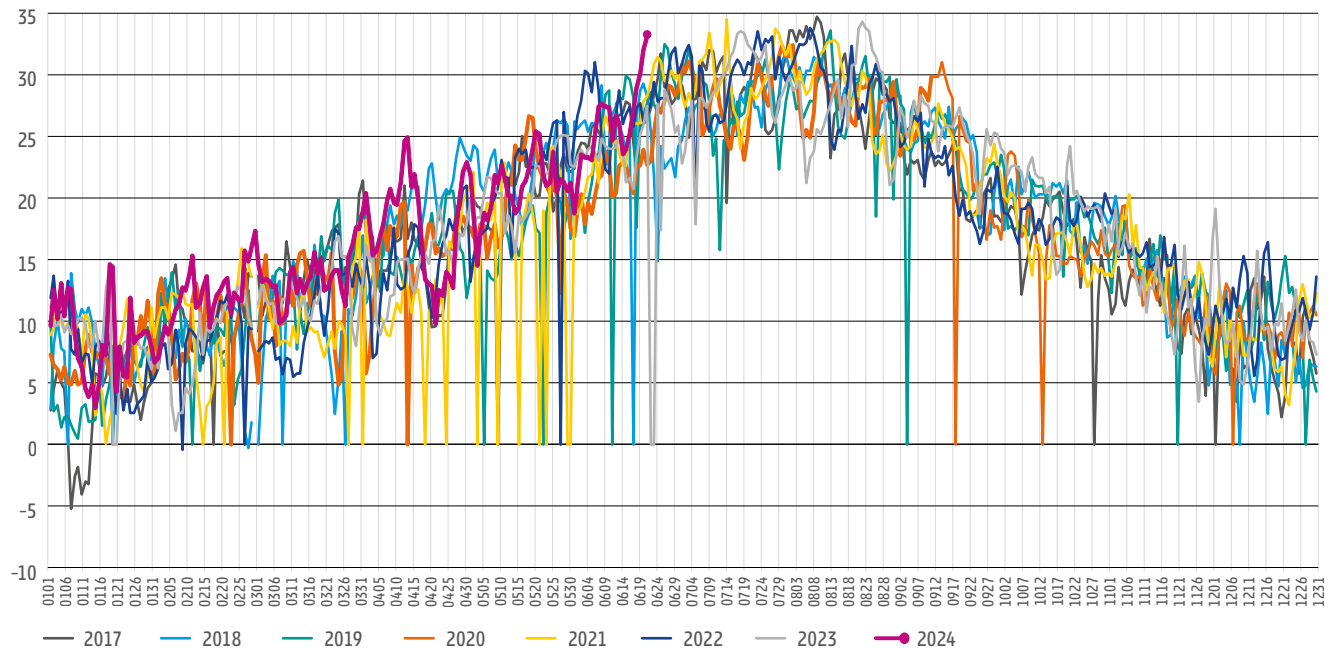
Figure 4: Average daily temperature in last 8 years in Podgorica in °C

An illustration of the average daily temperatures in the last 8 years in Podgorica (Figure 4) clearly shows the 21 June (as well as several previous days) was the hottest 21 June in the observed period (2017–2024).

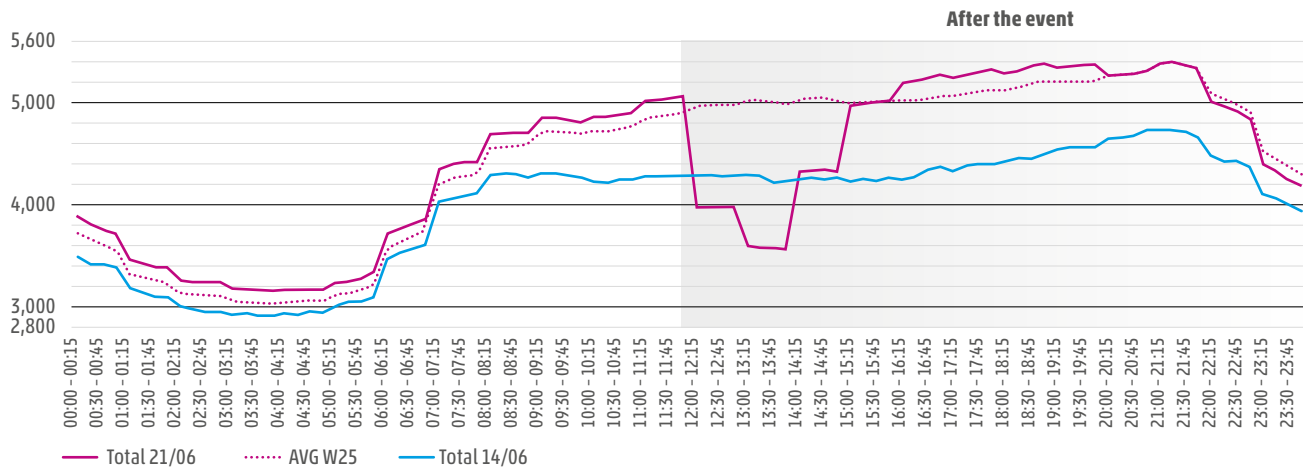
Figure 10: Aggregated daily load curves of 4 affected TSOs (OST, CGES, NOSBiH and HOPS) for the working week 25 (17 June - 21 June 2024) and 14 June 2024.

in four affected systems together ranging between 4 % and 6 %. The daily load curve on 21 June until the incident was well above the working week average (Figure 10), while total daily consumption, even with the blackout, was 7.8 % higher than on Monday of the same week and 10.3 % above the same day of the previous week (Friday 14 June).

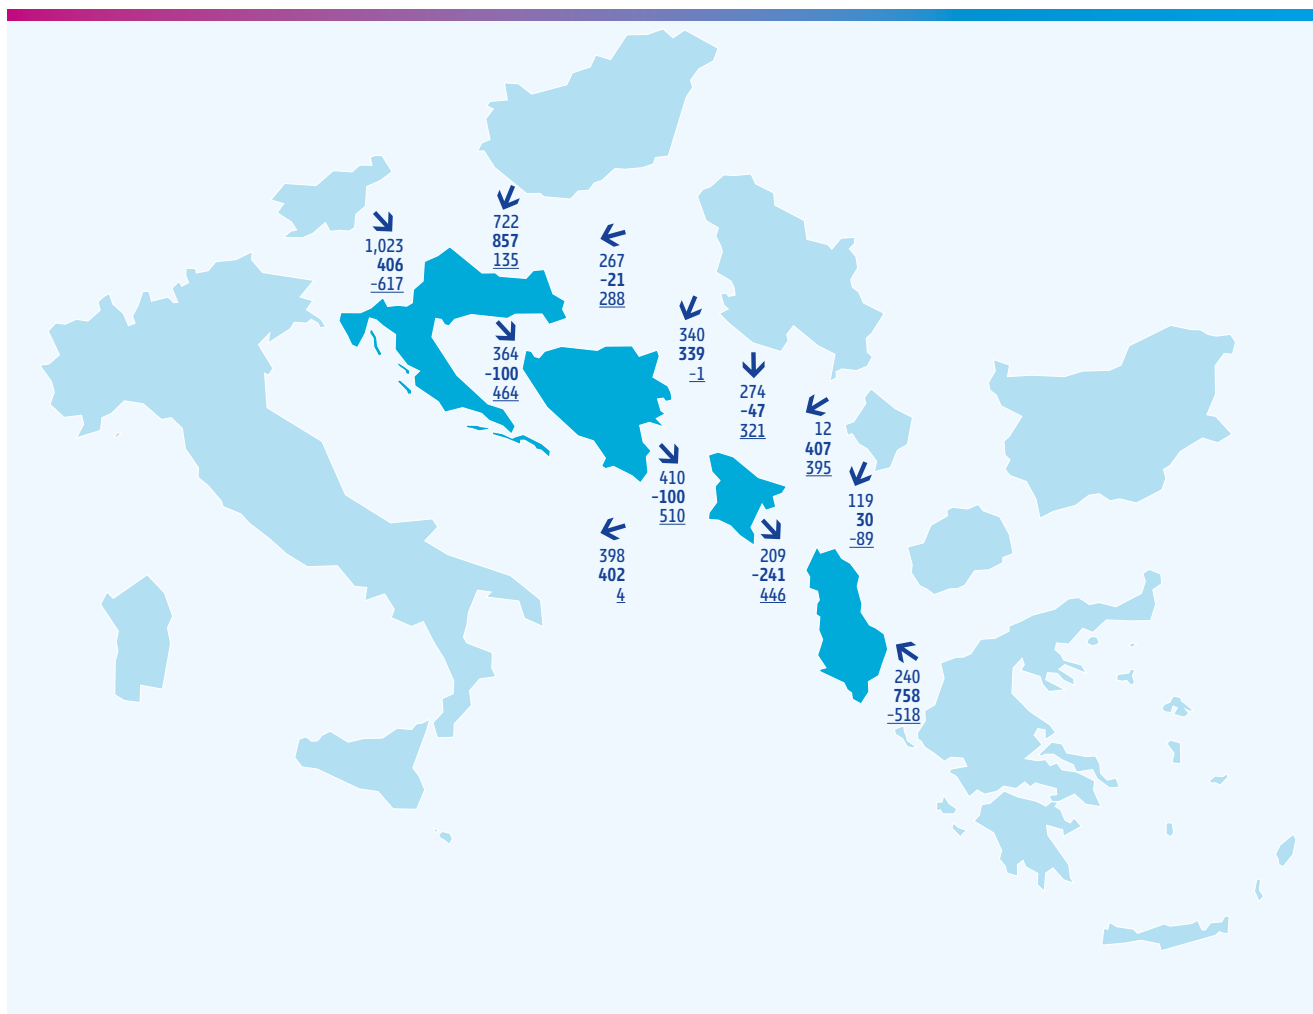
Figure 16: Cross-Border physical flows for 12th hour, 21 June 2024 (bold) and corresponding unscheduled loop-flows (underlined) in MW

In essence, the difference between the scheduled and physical flows (mainly loop-flows, as no significant system disbalances were recorded during the day) alongside the Adriatic coast was present on all the borders in the amount of approximately 500 MW.

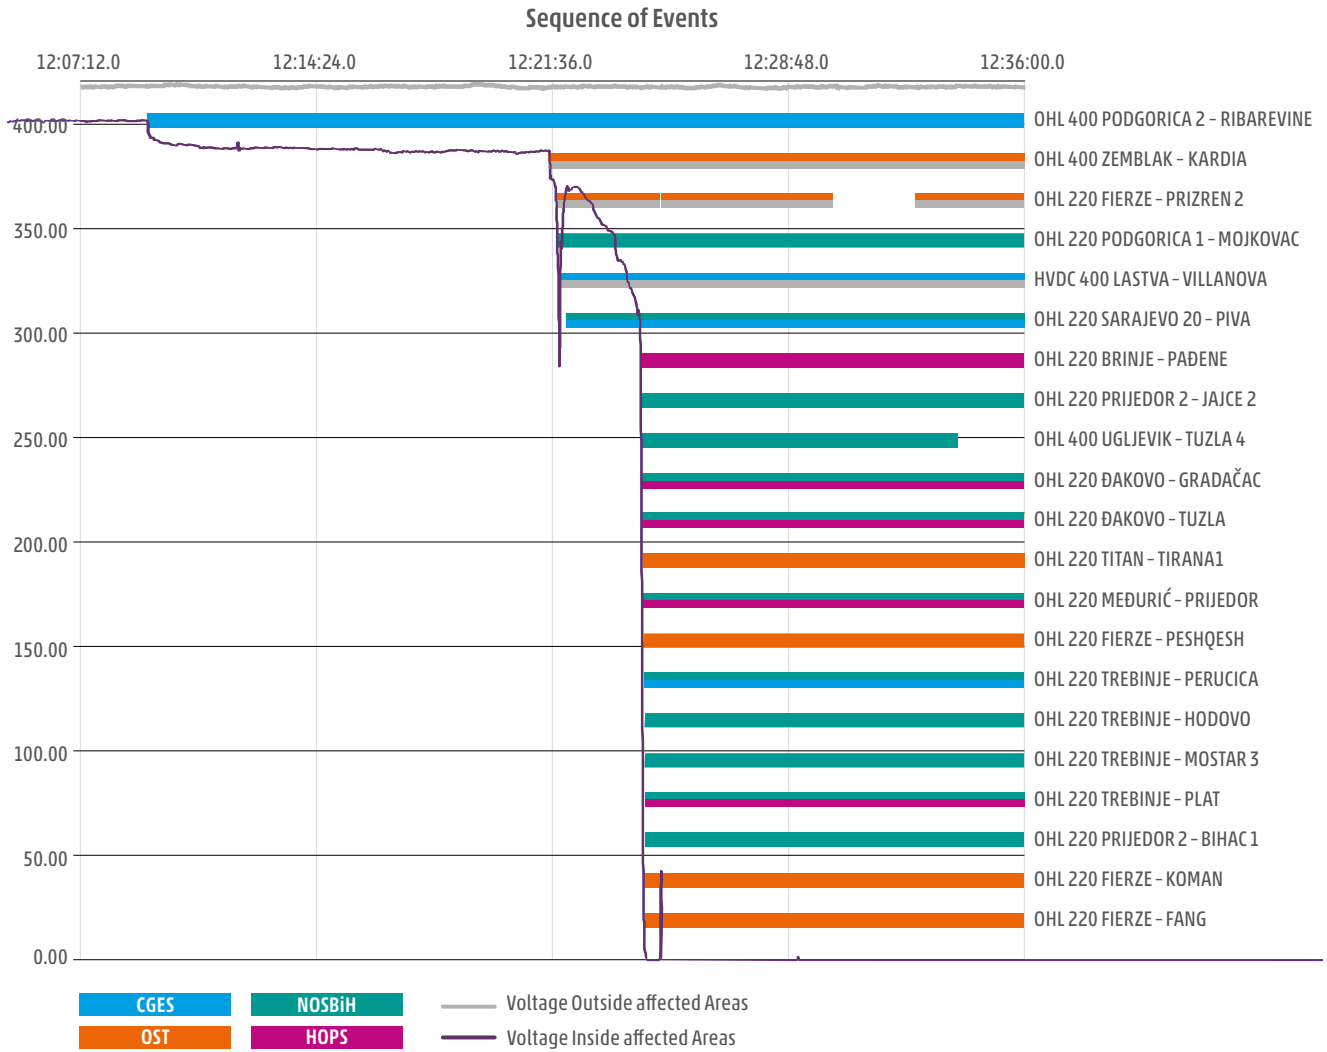
Figure 20 shows the sequence of events together with the voltage trajectory in substation Trebinje (NOSBiH) and in substation Tumbri (HOPS).

Figure 20: Sequence of Events plotted over voltage in substation Trebinje (NOSBiH) PMU data (purple) and voltage in substation Tumbri (HOPS); the length of the horizontal bars indicates the duration of the outage; two-colour bars indicate tie-lines (OHL 220 kV Fierze-Prizren, the separation of the bar indicates switching during restoration).

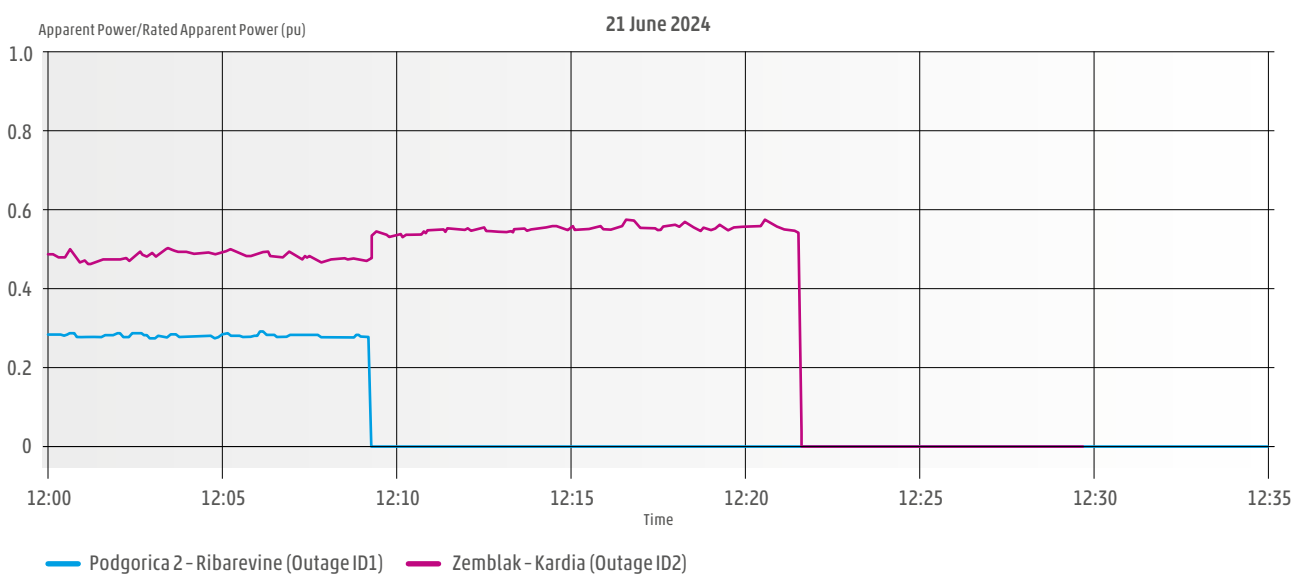
Figure 24: Evolution of line loadings (apparent power) of the lines with outage ID1 and ID2 whose outages triggered the cascading disconnections.

thermal capacity. Broadly speaking, apparent power in AC power systems is the total power supplied by the source, combining both the actual usable power (called active power) and the extra power that flows back and forth and cannot be used directly (reactive power).

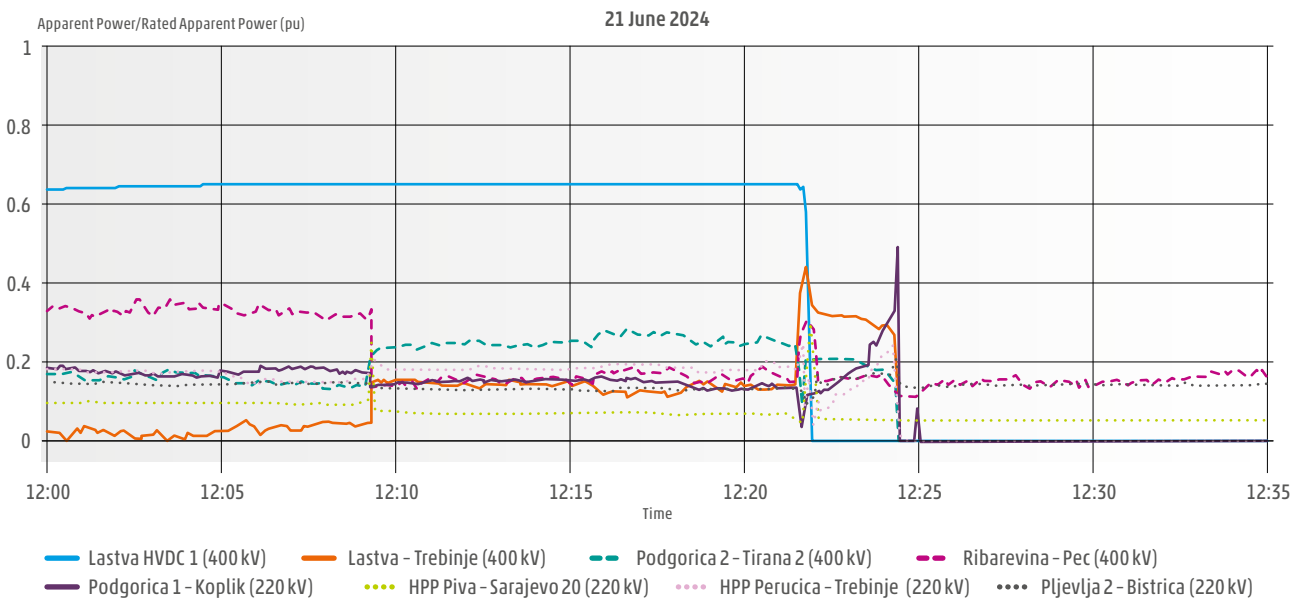
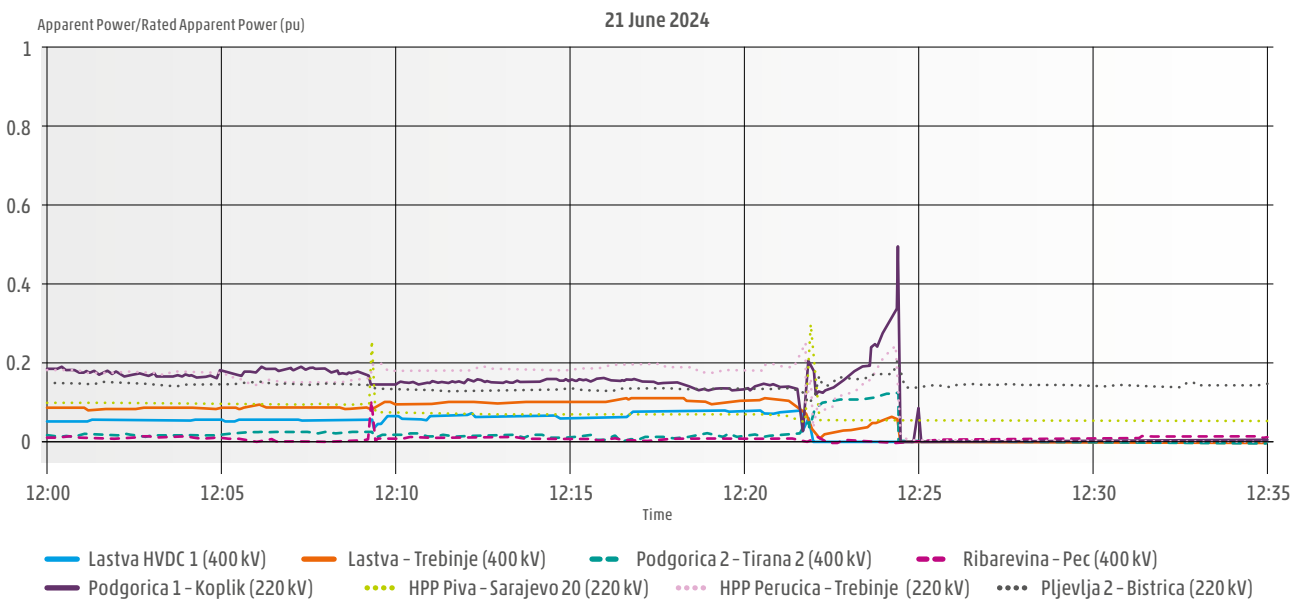
Figure 25 and Figure 26 show the line loadings within the CGES control area relative to their thermal capacity limits.

Figure 25: Evolution of line loadings (active power) in the CGES network.

Figure 26: Evolution of line loadings (reactive power) in the CGES network.

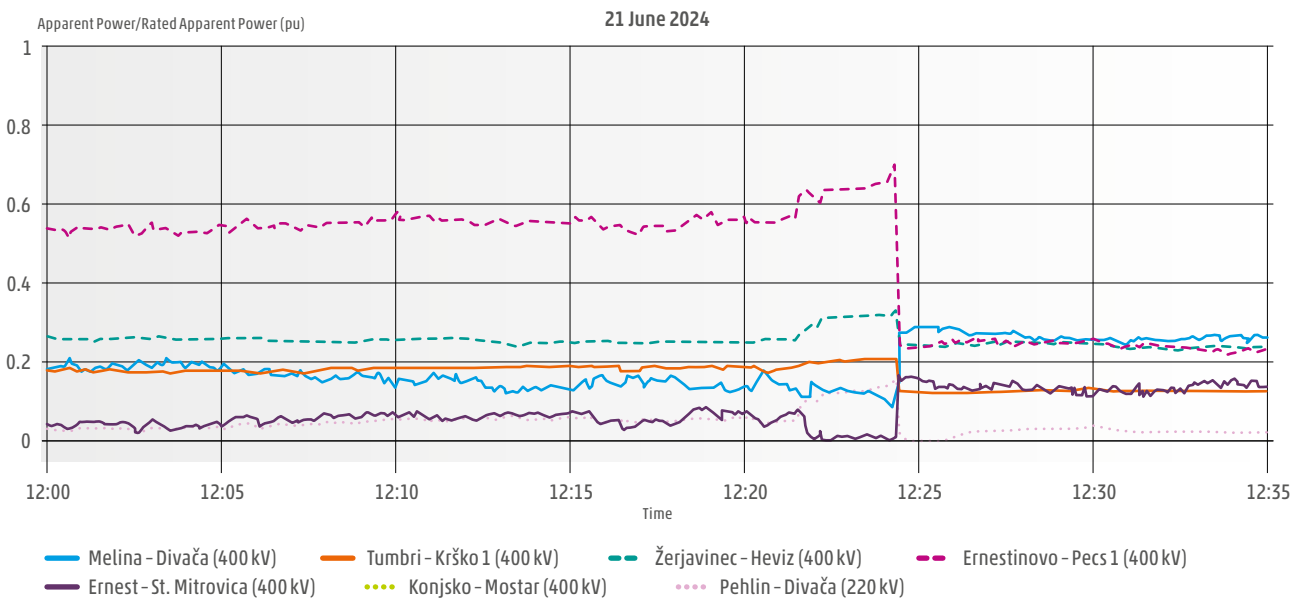
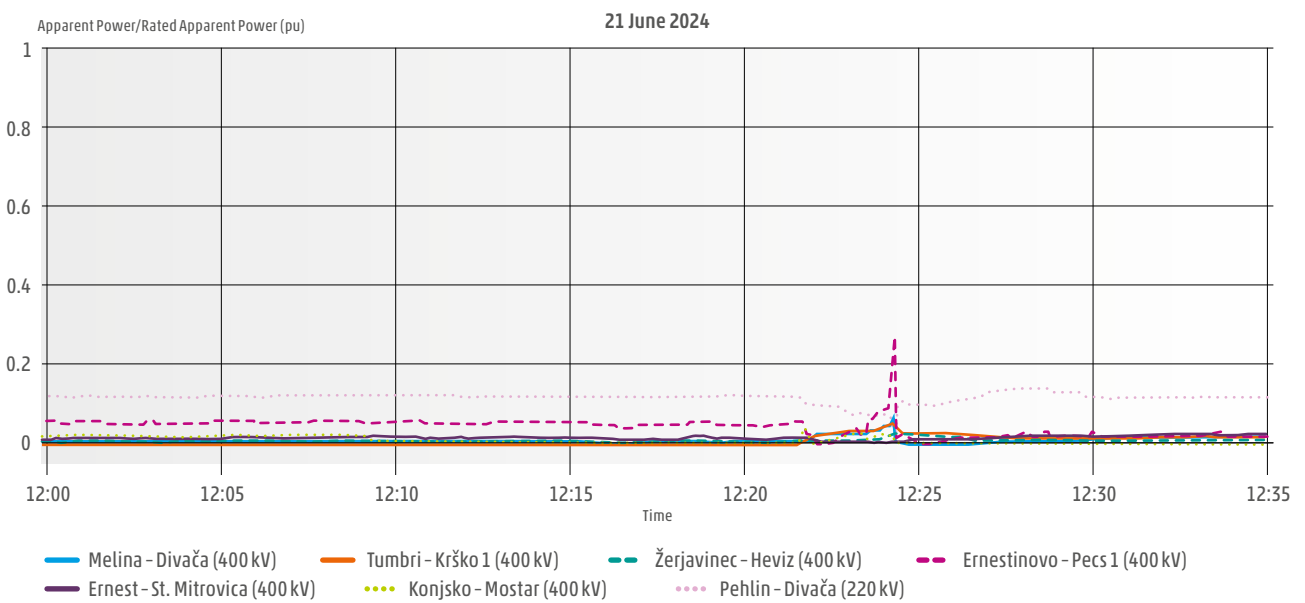
Figures 27 and Figure 28 show the line loadings within the HOPS control area relative to their thermal capacity limits.

Figure 27: Evolution of line loadings (active power) in HOPS network.

Figure 28: Evolution of line loadings (reactive power) in HOPS network.

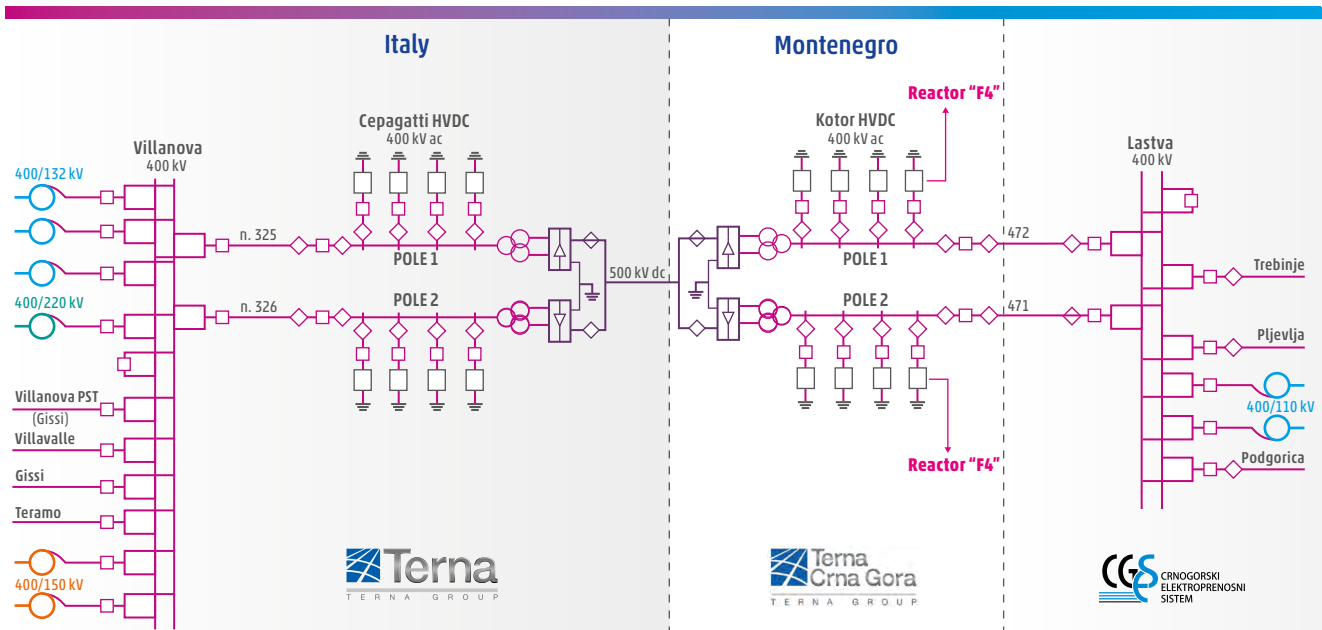
Figure 29: Simplified single line diagram of the 400 kV tie-line at the border between Terna and CGES

There is no possibility of reactive support from the HVDC link by regulating the reactive power due to the fact that the link is based on LCC⁸ HVDC technology.

8 Line-Commutated Converter (LCC) HVDC systems cannot regulate reactive power effectively due to their significant reactive power requirements at both the rectifier and inverter sides. This is caused by the delayed firing of thyristors, which leads to a lag between current and voltage waveforms, resulting in high reactive power consumption. LCC HVDC systems require external reactive power compensation devices, such as capacitors and reactors, to manage their reactive power needs. This dependence on external devices limits their ability to regulate reactive power independently.

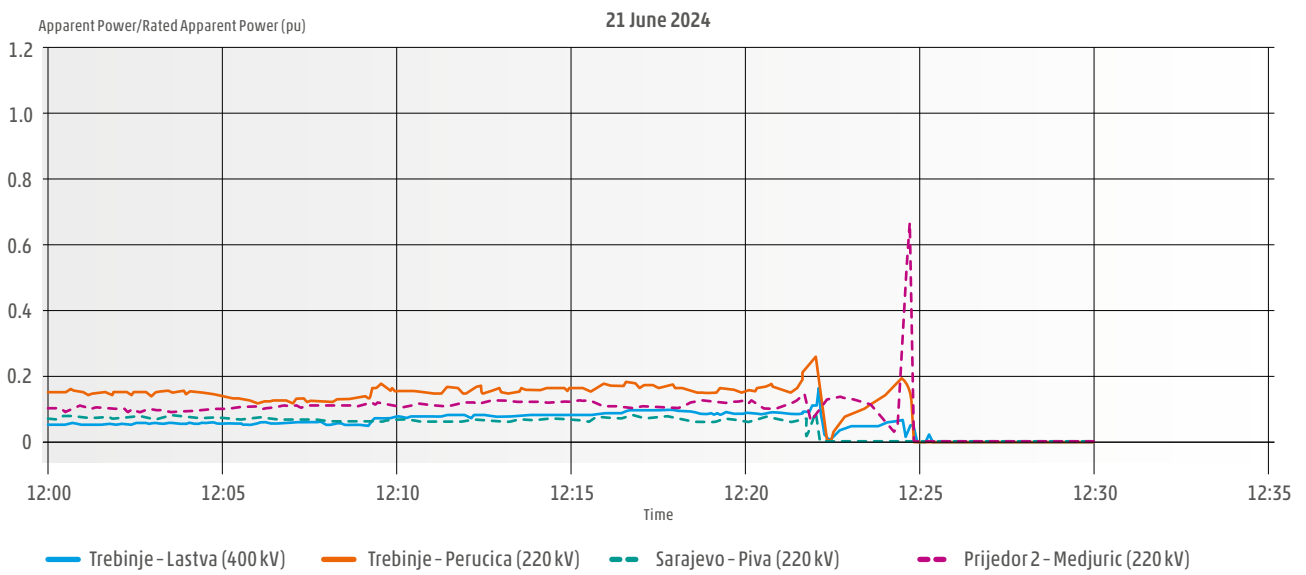
Figure 30 and Figure 31 show the line loadings within the NOSBiH control area relative to their thermal capacity limits.

Figure 30: Evolution of line loadings (active power) in NOSBiH network; "Sarajevo" refers to "Sarajevo 20".

Figure 31: Evolution of line loadings (reactive power) in NOSBiH network; "Sarajevo" refers to "Sarajevo 20".

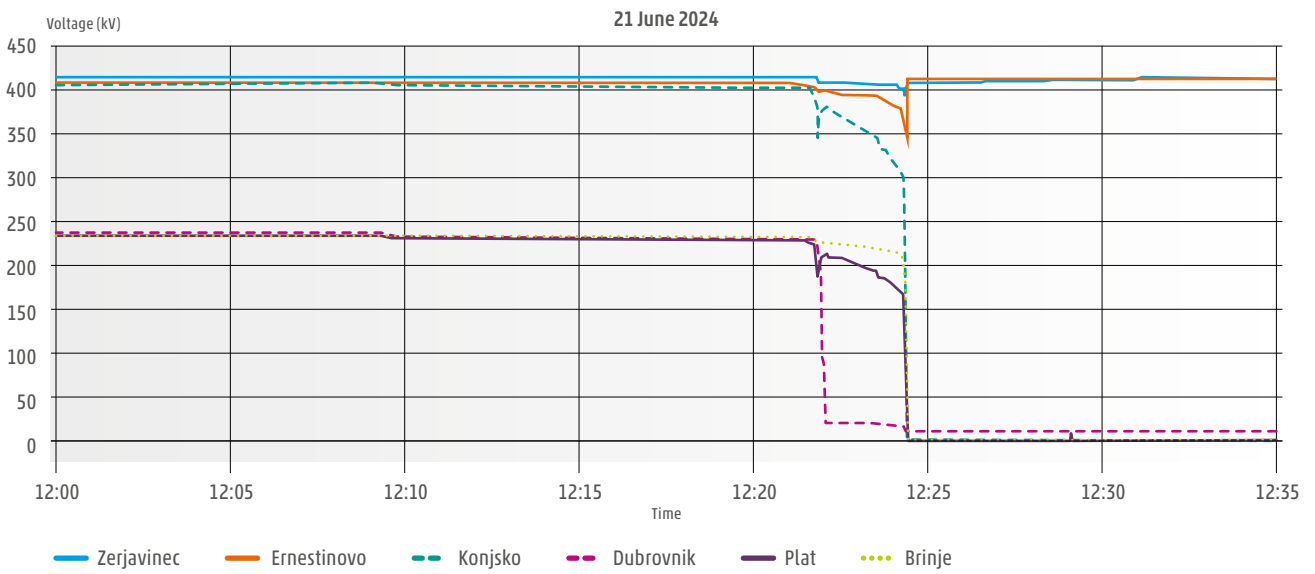
Figure 36: Voltage evolution in the HOPS network on the 400 kV and 220 kV level.

Figure 36 and Figure 37 show the voltage trajectories in the HOPS control area.
